Potlatch Corporation  
Resource Management Group  
Idaho Region

RE: Avery Landing Remediation

Subject: Avery Landing

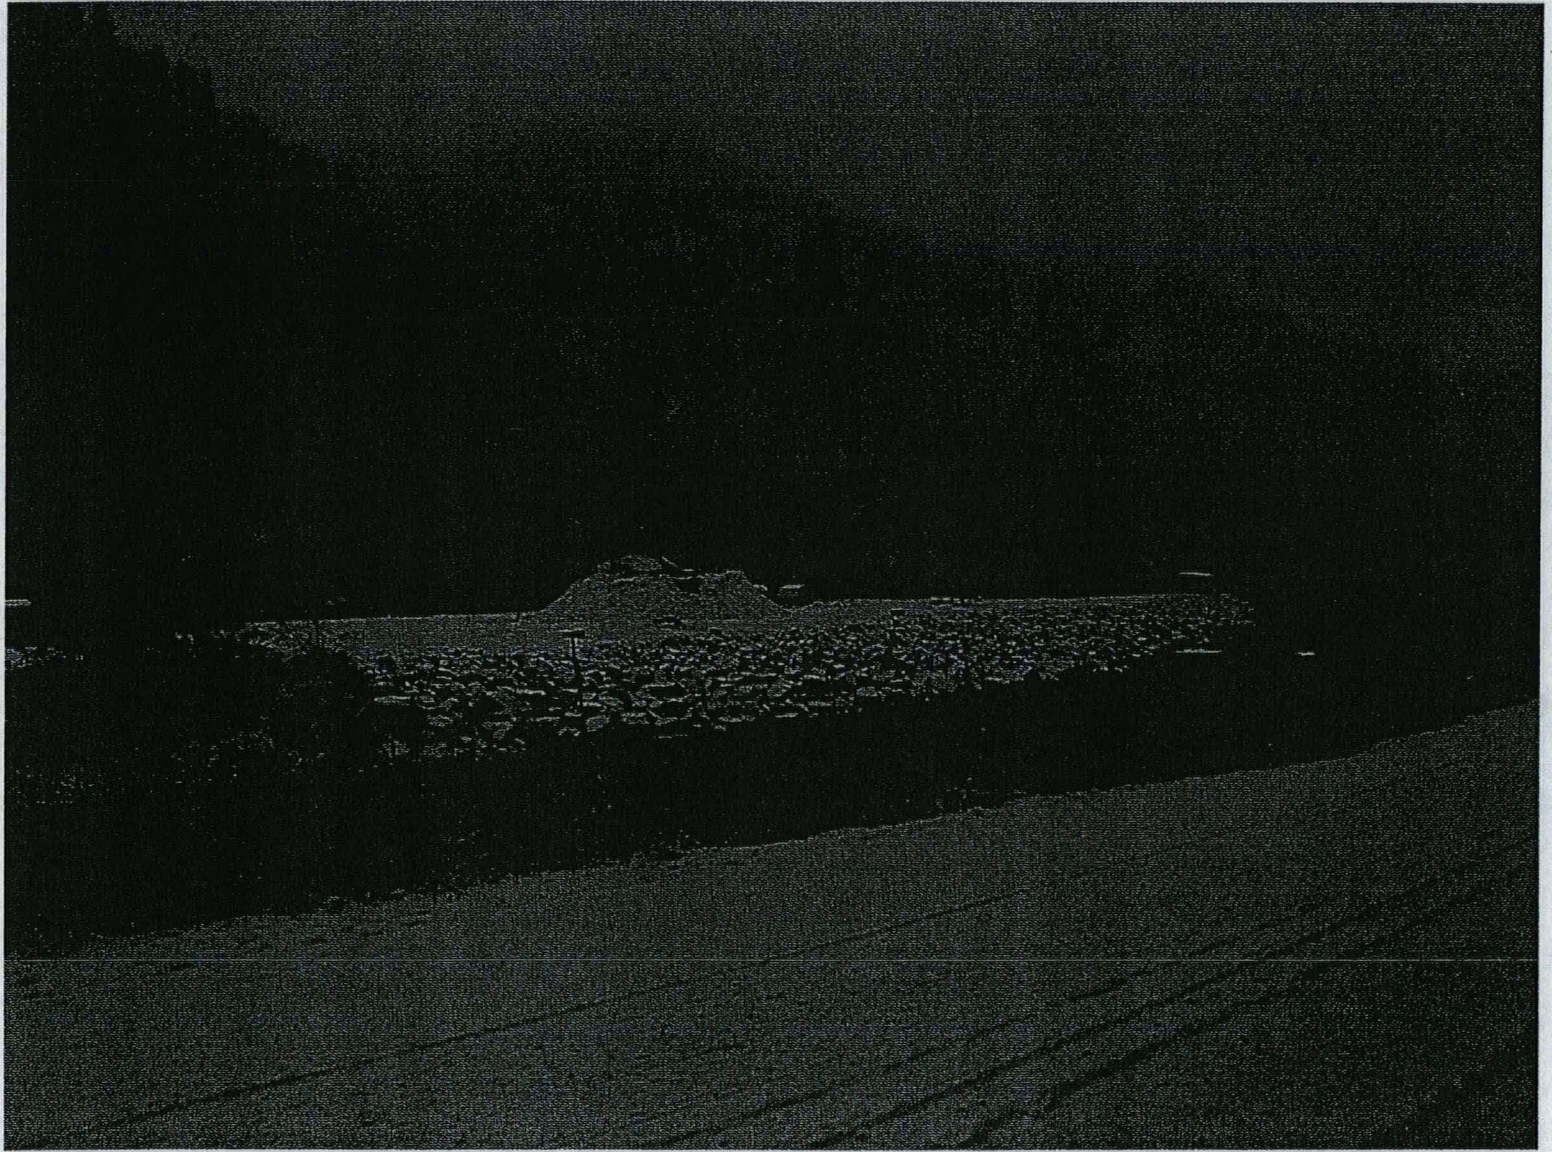
View of entire site from across(s) river

11/08/2000

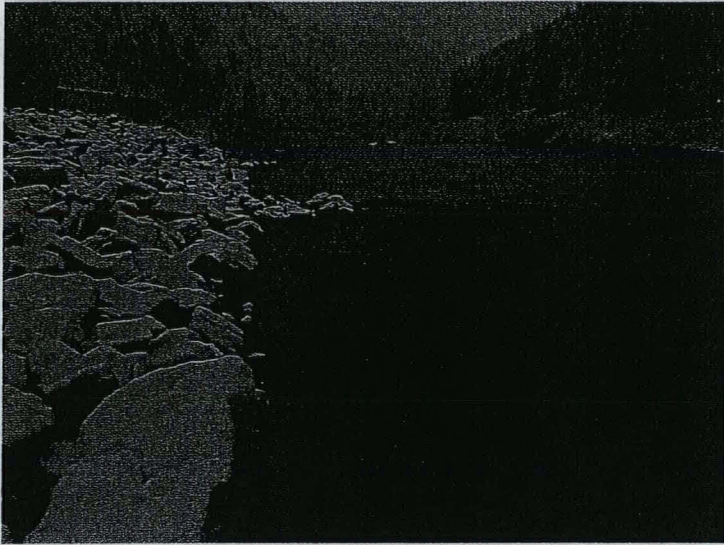
Avery Landing 012.JPG  
11/08/2000  
Viewing E across E end of site

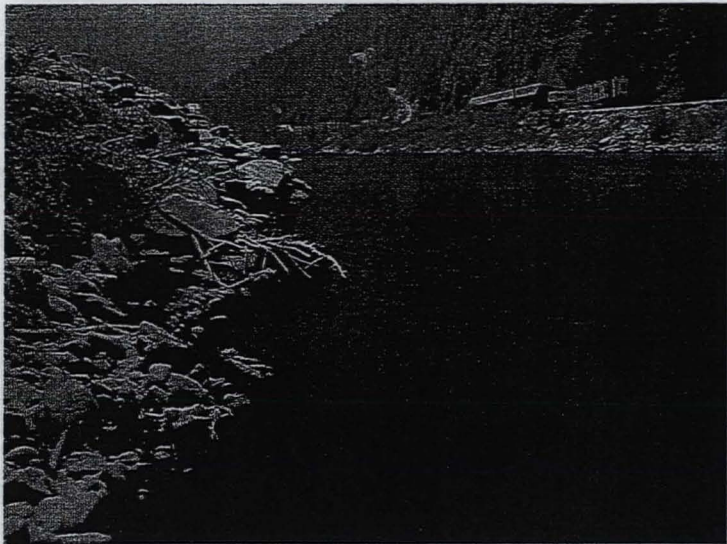
Avery Landing 008.JPG  
11/08/2000  
Viewing E, upstream, from far W end of site

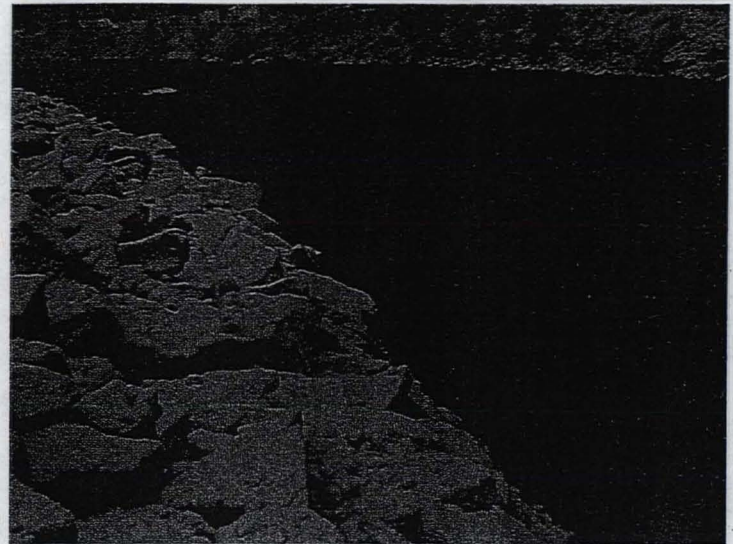
Avery Landing 009.JPG  
11/08/2000  
Viewing across the bank and upstream, 1/3 of the way E from W end of site

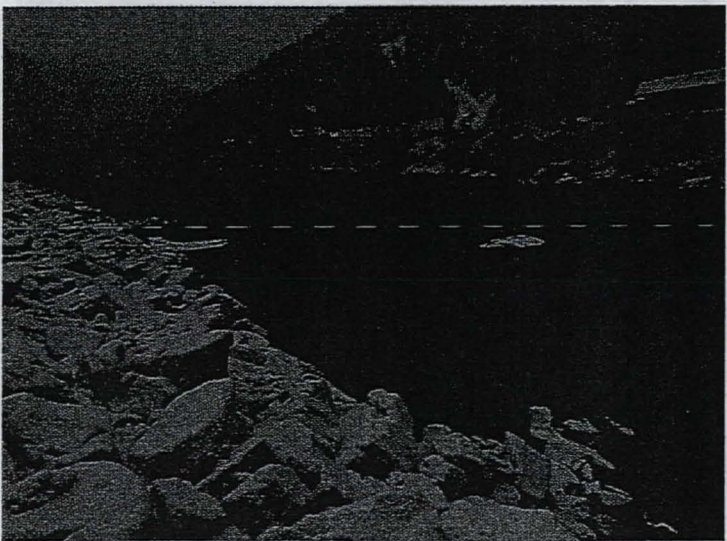
Avery Landing 010.JPG  
11/08/2000  
Viewing upstream in center portion of site. Wooden platform visible in center of photo

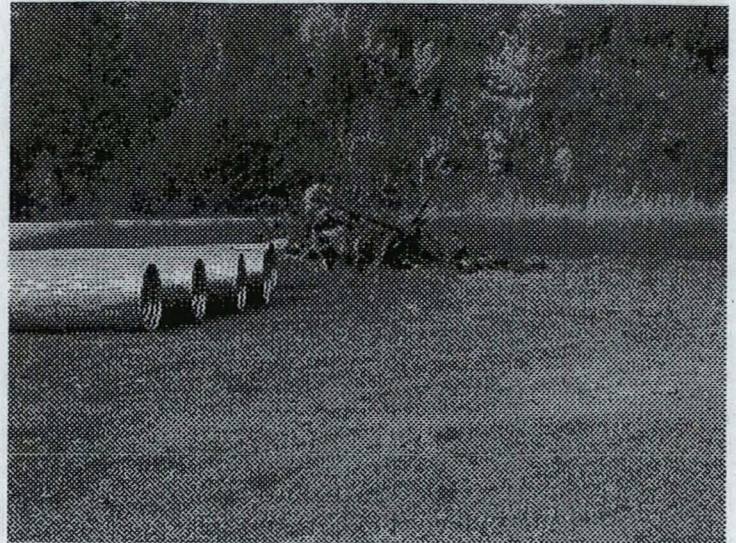
Avery Landing 013.JPG  
09/15/2000

Photo of 3' diameter recover pipes

*& junk metal that has been excavated  
from stream bank*
